To:	Dan Milne	From:	Kenneth Jamieson Adrienne Leech
	Operations/ Community Services Municipalities of North Cowichan 7030 Trans Canada Highway Duncan BC, V9L 6A1		400-655 Tyee Road Victoria BC, V9L 6A1
File:	115619176	Date:	November 22, 2019

## Reference: North Cowichan Fire Department Crofton Hall – 2nd Floor Load Rating Study

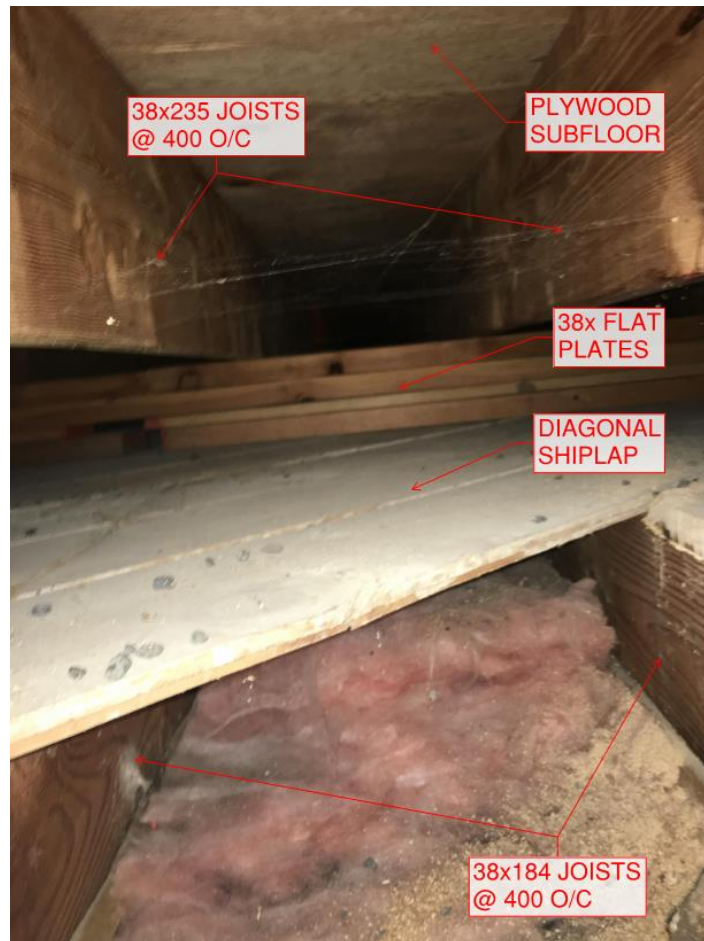
**Figure 1 – General View of Second-Floor Framing Above the Garage Bays**

During the previous assessment it was confirmed that the existing structure above the garage bays consists of diagonal shiplap supported by 38x184 joists at 400mm on center, spanning 3.66m. The joists are supported by 130x494 glulam beams spanning 8.4m, supported midspan by steel columns. During the site review conducted on November 13, 2019, it was found that there are additional floor joists above the garage bays consisting of 38x235 joists at 400mm on center. The joists span 3.66m and are supported approximately

every 2.0m by stacked 38mm thick flat plates. The additional joists generally bear directly above the original joists, as seen in **Figure 1**.

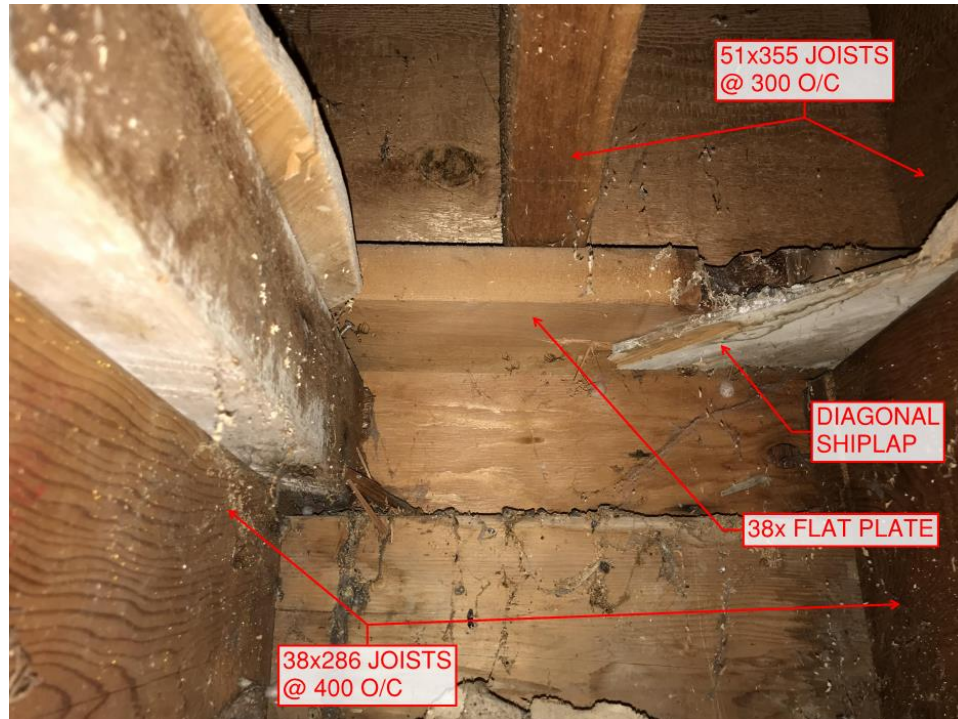
**Figure 2- General View of Second Floor Framing Above Office Area at Exterior Wall**

The existing structure above the office area was confirmed to be diagonal shiplap supported by 38x286 joists at 400mm on center spanning 6.75m. The joists are supported by load-bearing CMU and wood stud walls. There are also additional floor joists above the office area consisting of rough sawn 51x355 joists at 300mm on center. The joists span 6.75m supported approximately every 2.0m by 38mm thick flat plates. The additional floor joists are at a different spacing than the original roof joists; therefore, they do not bear directly on top of each other, as seen in **Figure 2**.

As seen in the **Figure 2**, the 51x355 joist bears midspan on a single 38x140 flat plate, spanning 400mm between the original 38x286 roof joists. Due to the spacing of the joists, it is likely that this condition occurs along both bearing walls above the office area.

In the current condition, the live load capacity of the floor is limited to 1.25 kPa (25 psf) due to the inadequate capacity of the single 38x140 flat plate. Stantec has found that if the bearing condition is corrected the live load capacity of the floor can be increased to 2.4 kPa (50 psf).

- If North Cowichan seeks to increase the live load capacity of the second floor, Stantec recommends completing structural upgrades to correct the bearing condition at the load-bearing walls above the office area. This will increase the live load capacity of the second-floor to a maximum of 2.4 kPa (50 psf), allowing the space to be used for office occupancy loads. However, this will not allow the space to be used for assembly occupancy loads or storage loads. Repairing the bearing condition does not address the seismic deficiency of the structure or increase the seismic capacity. Stantec would still advise that the Crofton Firehall undergo a seismic upgrade or replacement.
